# Seismic Performance of Steel Pipe Pile to Cap Beam Moment Resisting Connections

## Final Report

North Carolina State University  
Raleigh, North Carolina

January 2013

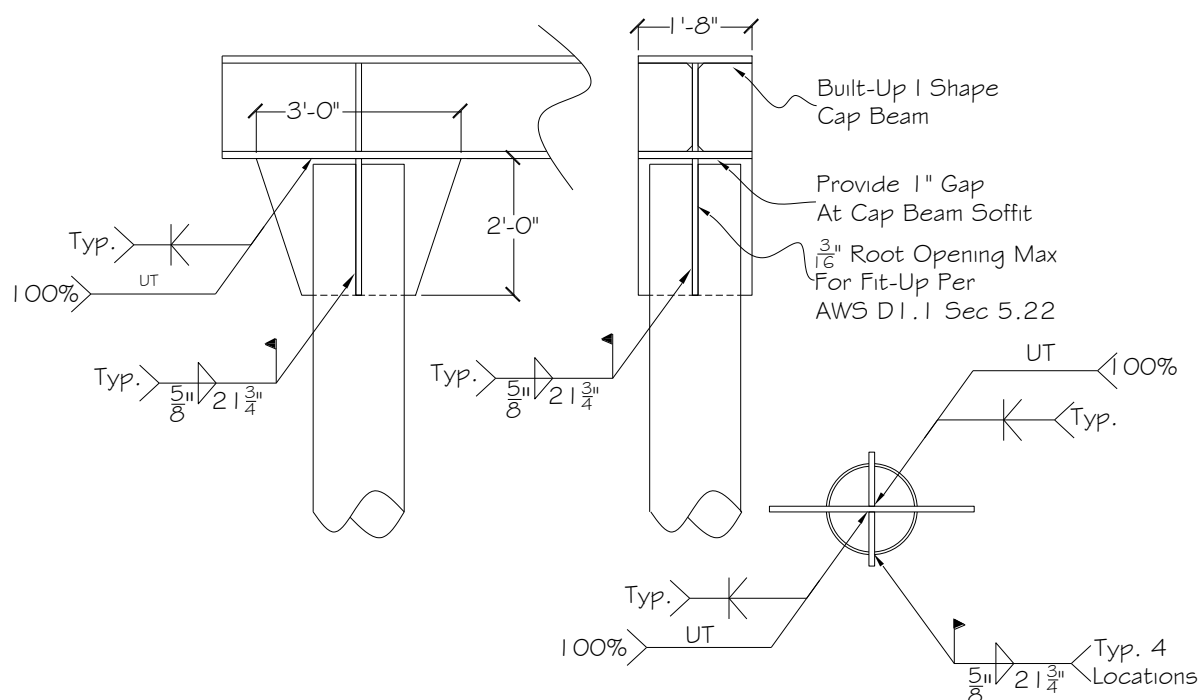
**Figure 9.3 Kerf Connection Detail**

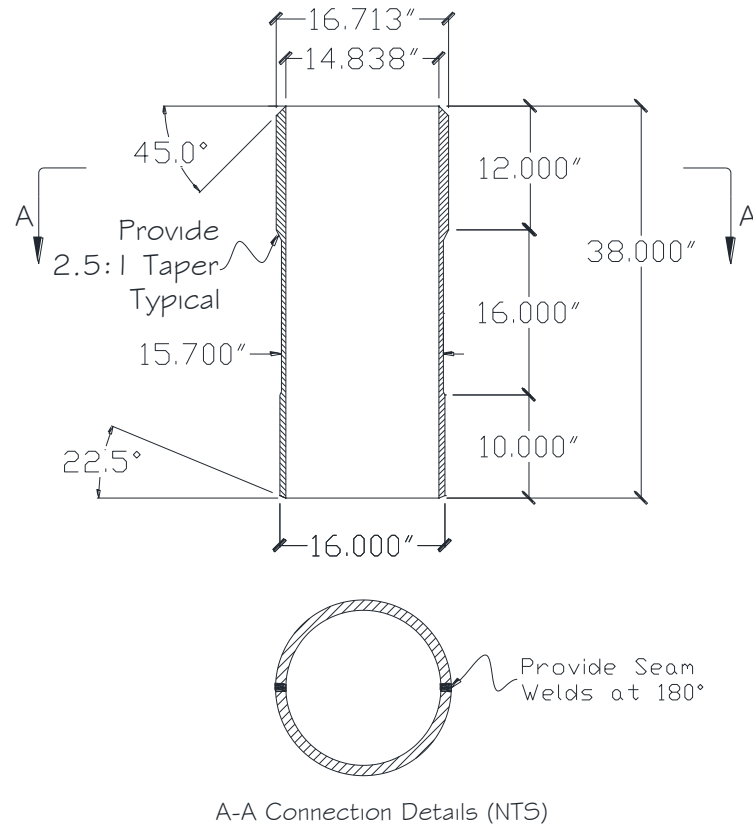
**Figure 9.6 Modified Column Capital Details**

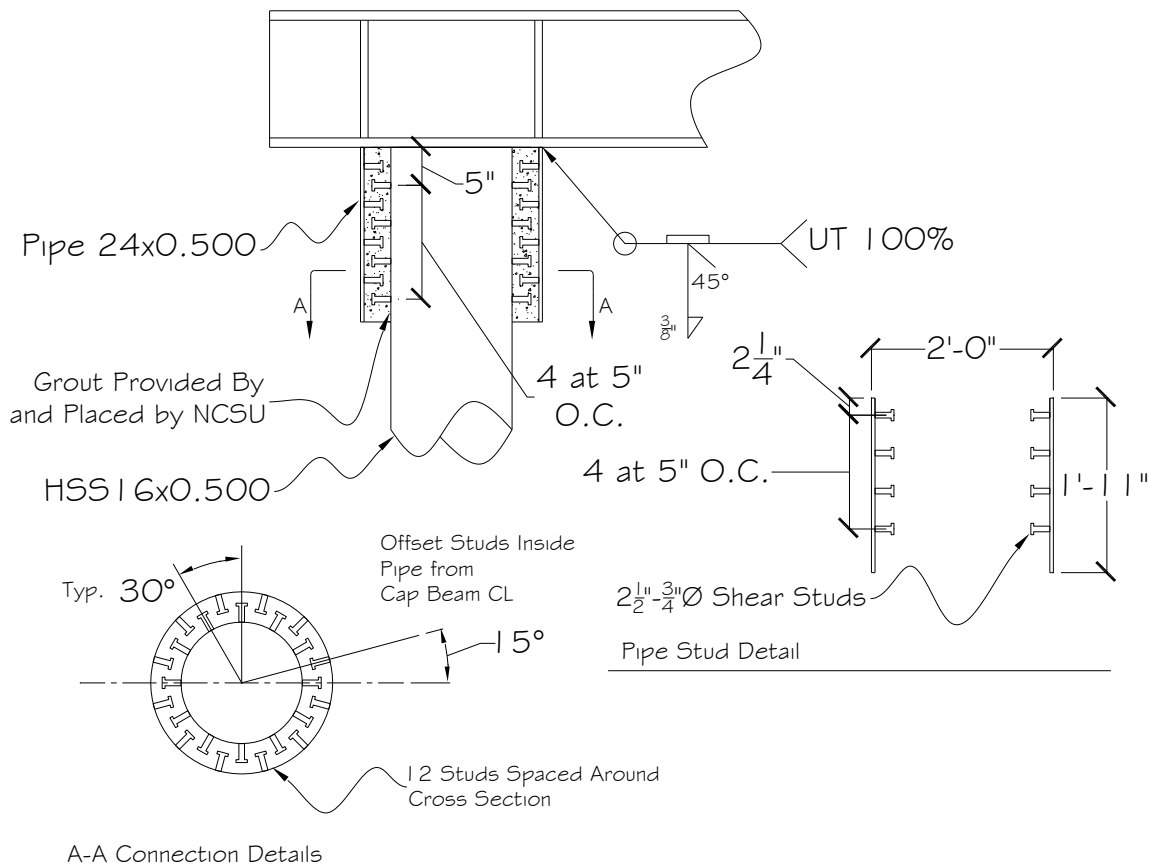
**Figure 9.7 Grouted Shear Stud Connection Details**

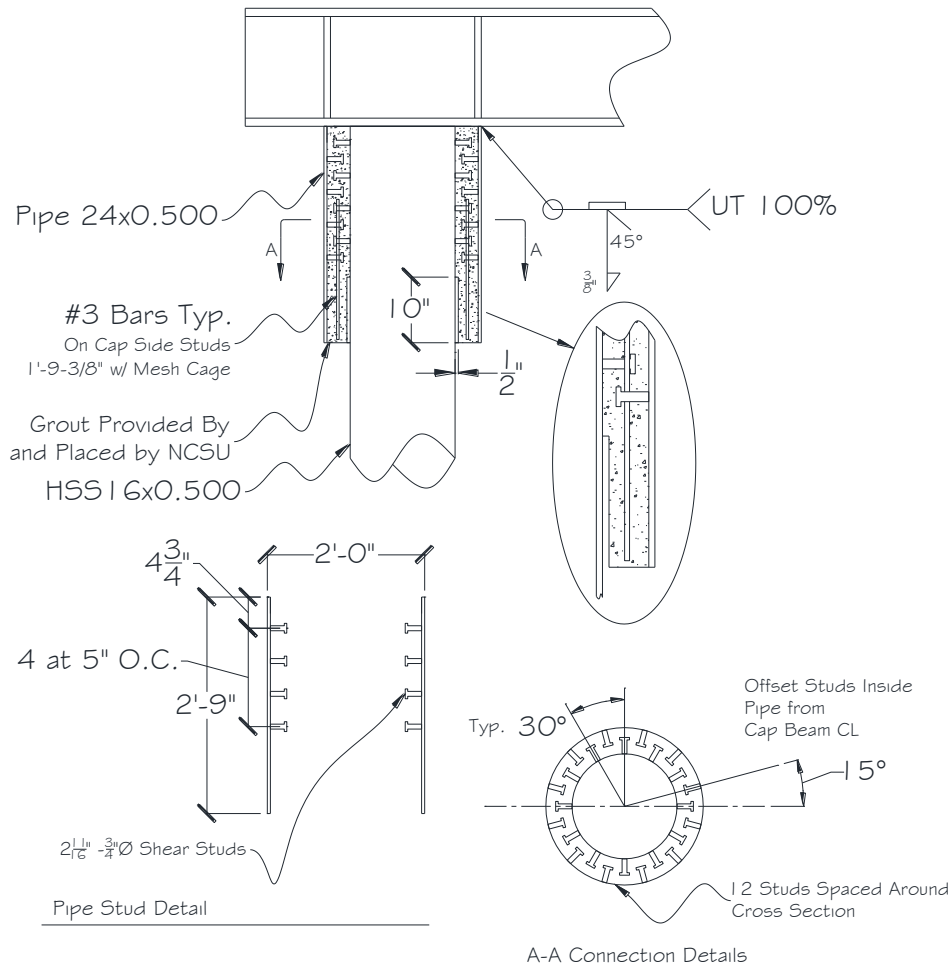
**Figure 9.8 B.R. Grouted Shear Stud Connection Details**

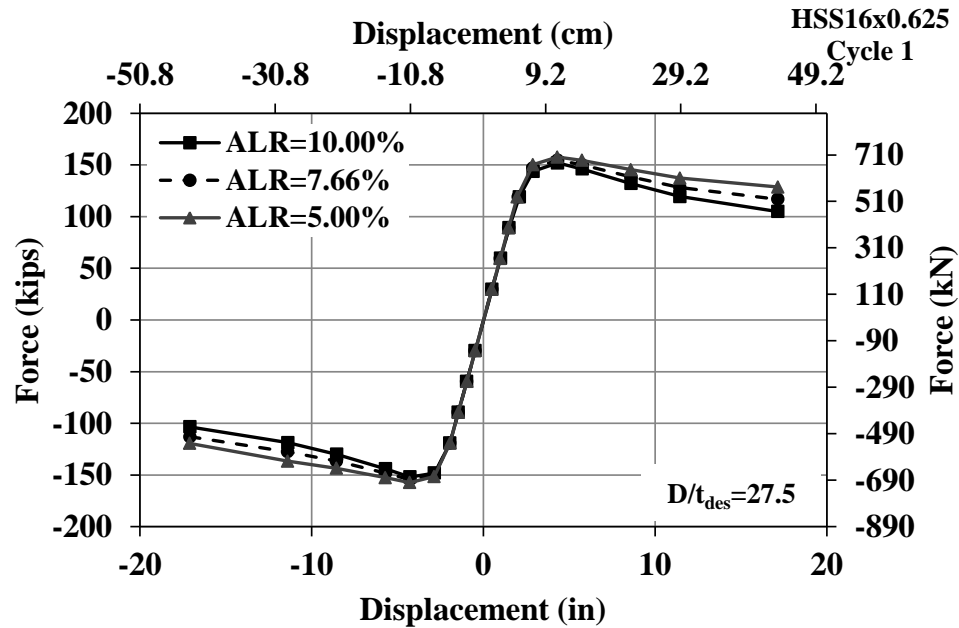
Figure 9.10 Cycle 1 Comparison – HSS16x0.625  $D/t_{des}=27.5$

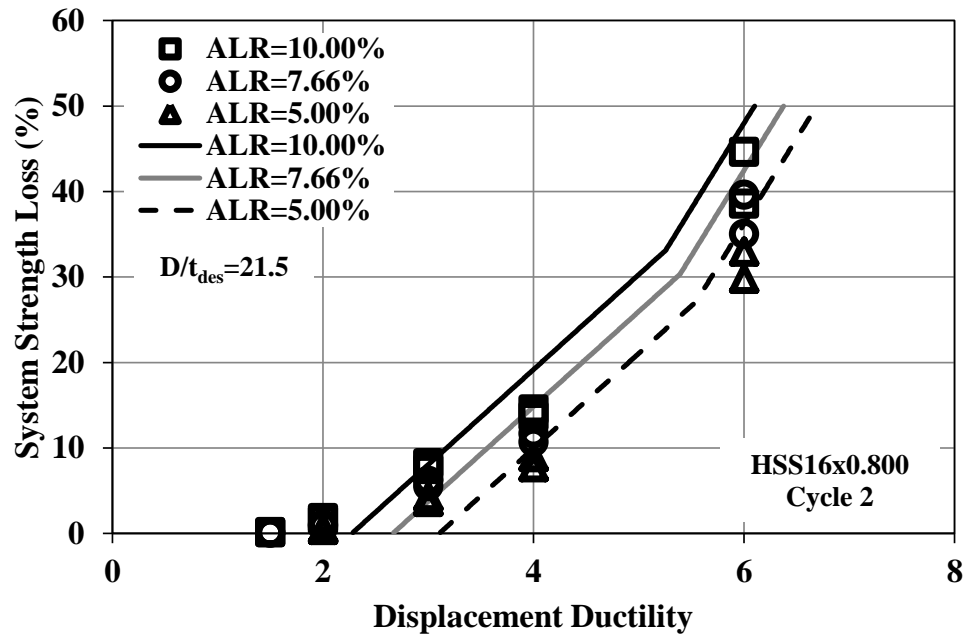
Figure 9.18 Multi-Linear Regression Analysis Results – Cycle 2 –  $D/t_{des}=21.5$

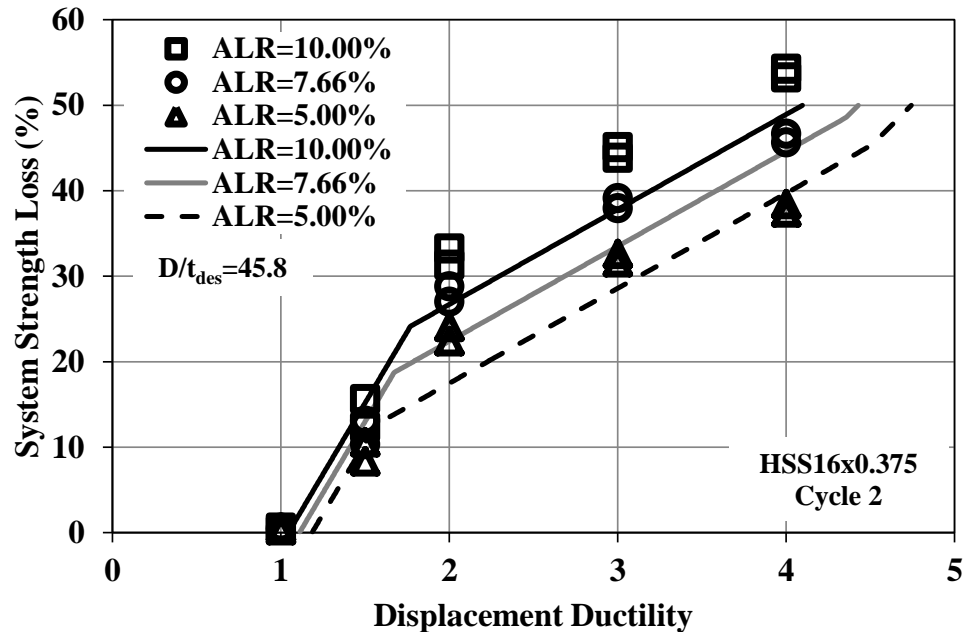
**Figure 9.19 Multi-Linear Regression Analysis Results – Cycle 2 –  $D/t_{des}=45.8$**

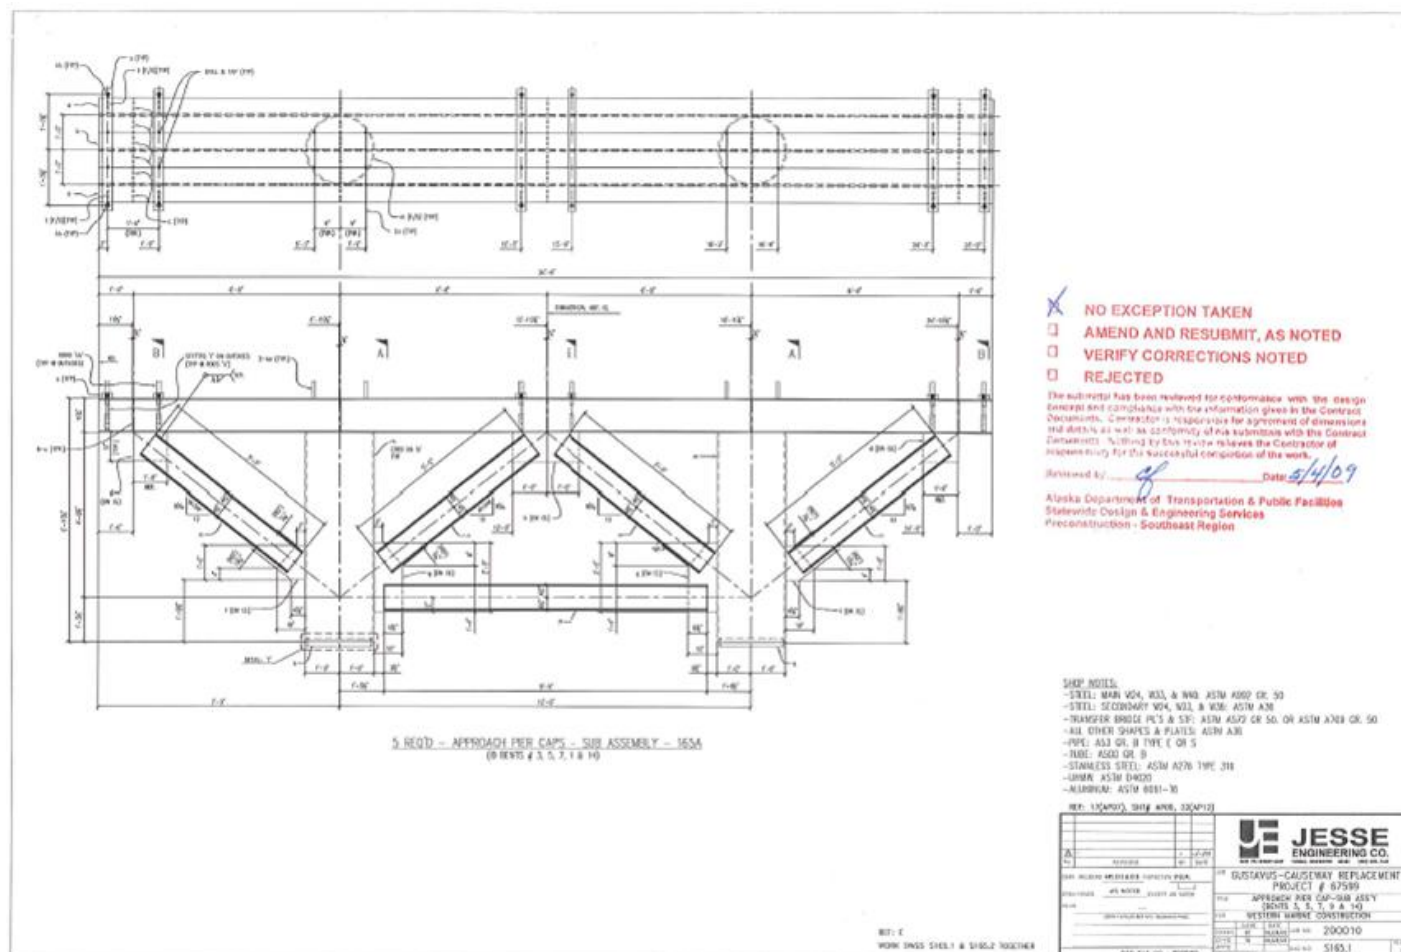
Figure A 84 Gustavus-Causeway Replacement Project Shop Drawings (Provided by AKDOT)

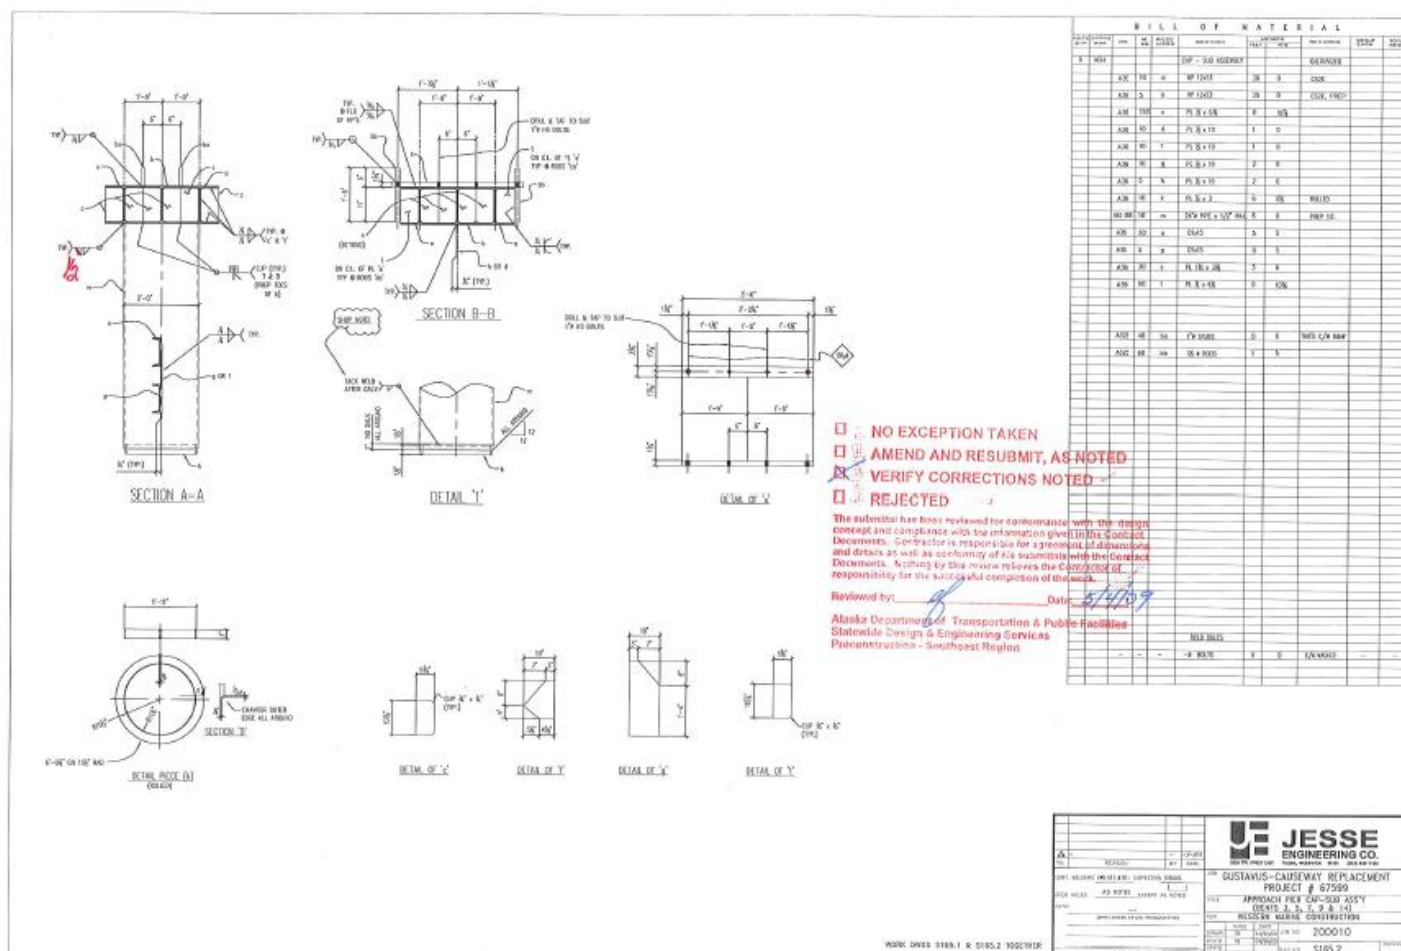
Figure A 85 Gustavus-Causeway Replacement Project Shop Drawings (Provided by AKDOT)
